# TECHNICAL JOURNAL

Volume 4 | Issue 1 | 2022

# 04: Humber Bridge Hanger Replacements and Testing in the UK

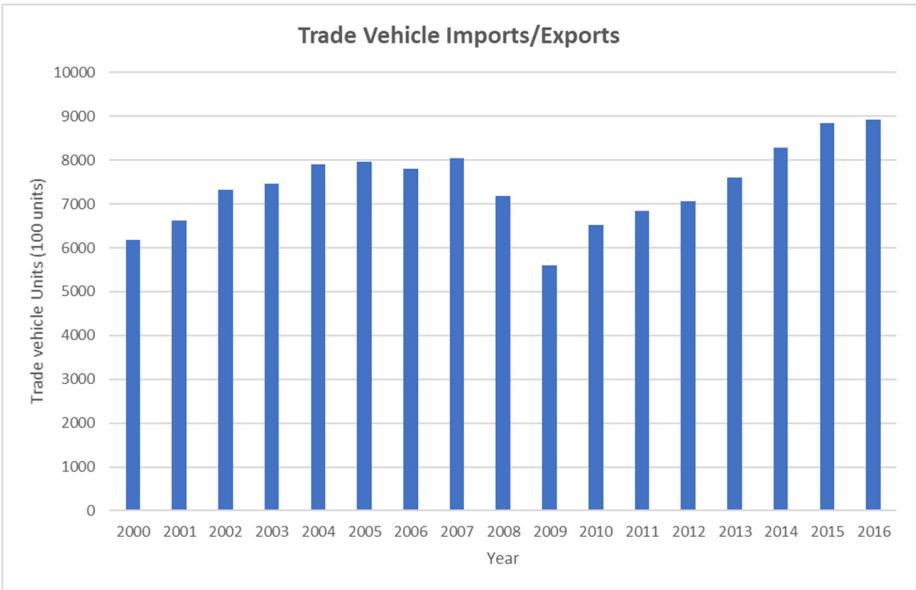
FIGURE 2-3

UK major and minor ports, import and export trade vehicles, 2000-2016

The development of Tilbury2 is primarily targeted at the RoRo trade and the aspiration was for the site to be able to handle some 500,000 units per annum. Some perspective on this ambition can be given from the unaccompanied freight traffic statistics in 2014 from Port of London, Felixstowe, and Harwich (Table 2-1). After the significant slump in trade following the financial crash in 2008, there was a very significant growth trend (See Figure 2-2), so the opportunity presented a chance to attract market share in favourable trading circumstances. POTLL already had an unaccompanied RoRo trade which was served from the impounded dock, so there was a great attraction in expanding this. POTLL also traded in import/export trade vehicles, mostly from the pontoon linkspan near to the cruise berth. Tilbury2 presented an opportunity to expand this trade, as well. Figure 2-3 indicates that this trade was also experiencing significant growth.

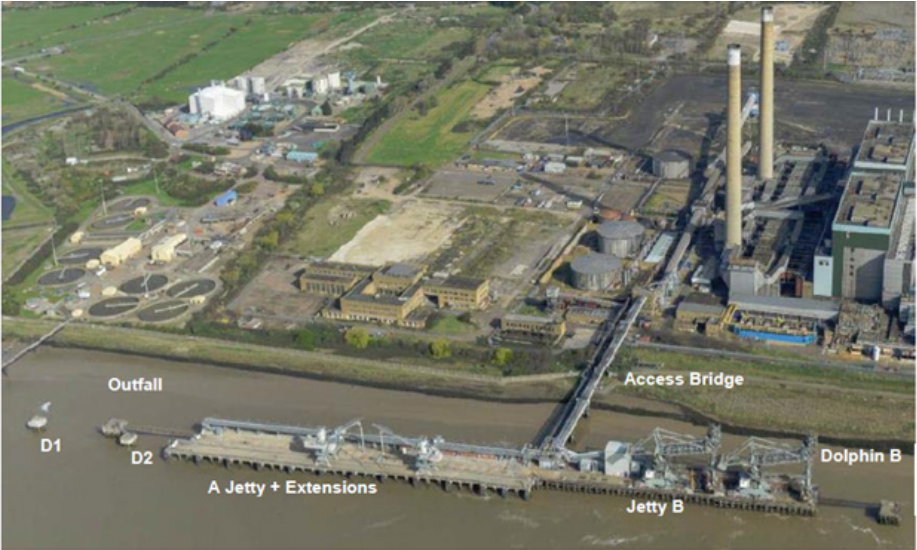
FIGURE 2-4

The B jetty, built at the time of the B station construction, is 139 m long and 18.3m wide. This jetty had a dredged depth of around -7.2 CD when last surveyed but was typically dredged to 9.3m water depth. The arrangement of the various parts of the jetty is shown in Figure 2-4.

Tilbury2 - The jetty as it existed in 2016

The existing jetties are described in outline in Section 2.4.1 and illustrated in Figure 2-4, but in summary:

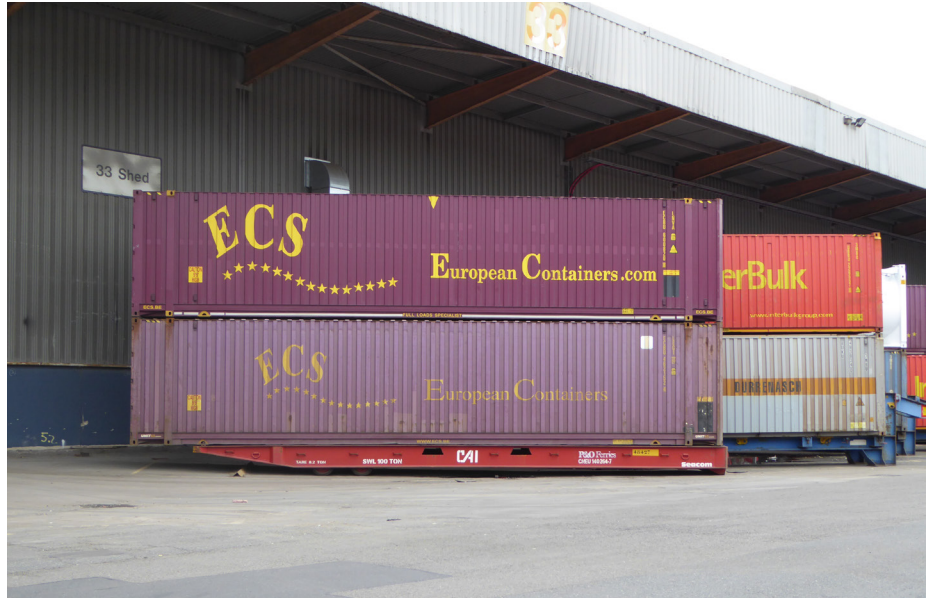
FIGURE 3-4

Container on RoRo  
operations in Port of  
Tilbury (before Tilbury2)

A) 45' containers on rolltrailers (note extensions of containers)

- › Bringing the truck (HGV truck with flatbed trailer and container) to the terminal
- › Placing the container onto roll trailers 2 high (see Figure 3-4)
- › Taking to the marshalling area for embarkation
- › Embarking the vessel and placing into parking lanes on the ship

Figure 3-4 shows a typical container on RoRo operations from the original Port of Tilbury (see also Figure 2-6).

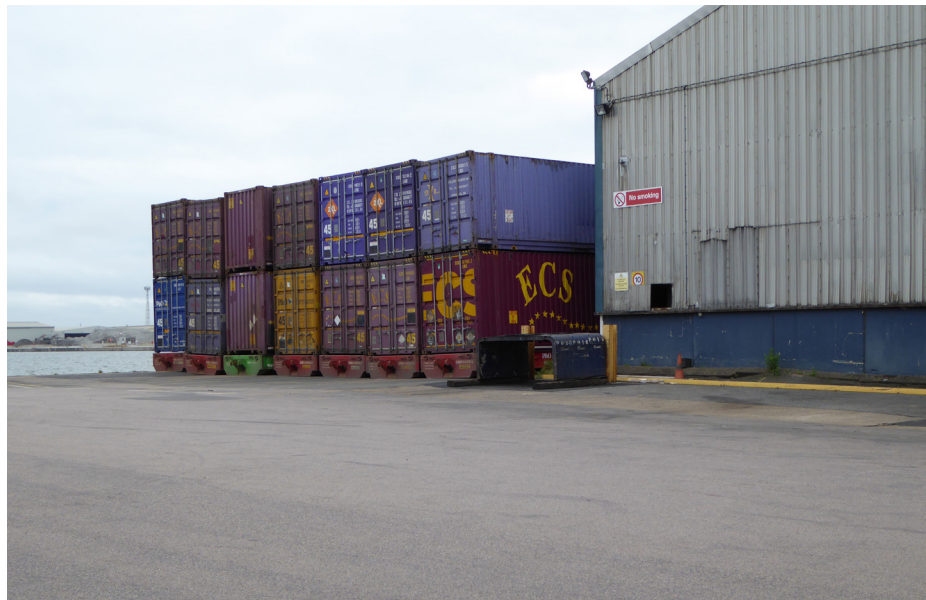
B) Rolltrailers and containers marshalled for export

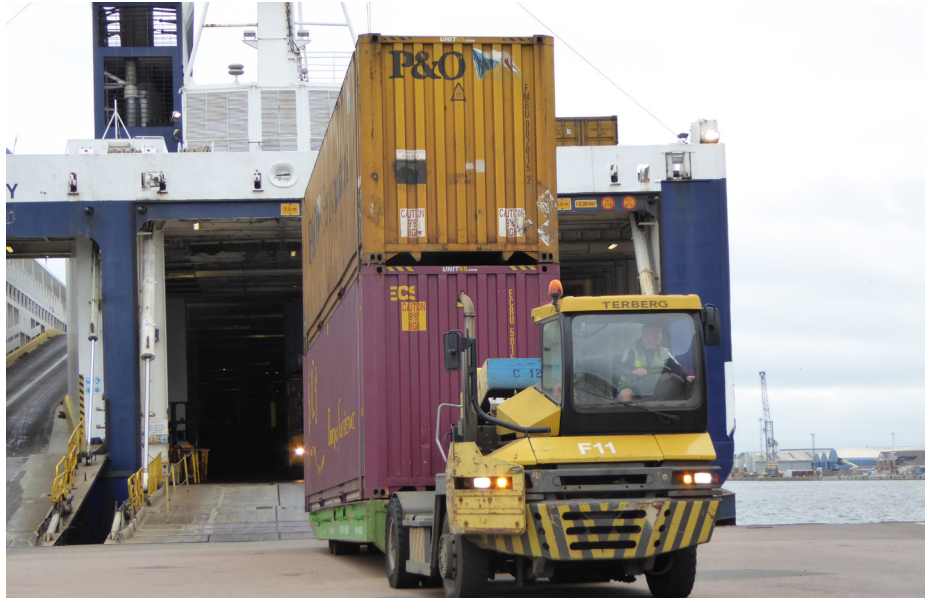
C) Containers disembarking

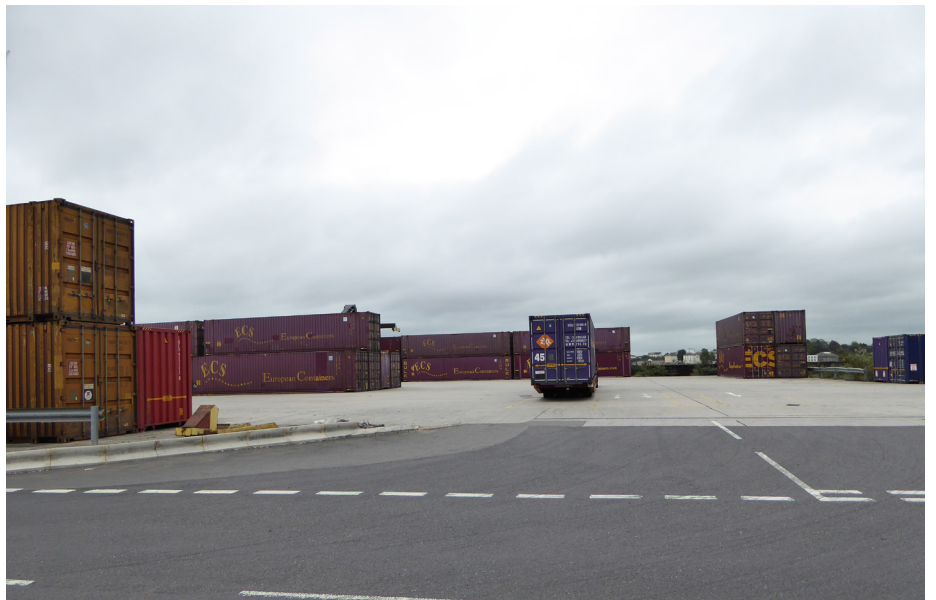
D) Import container stacks

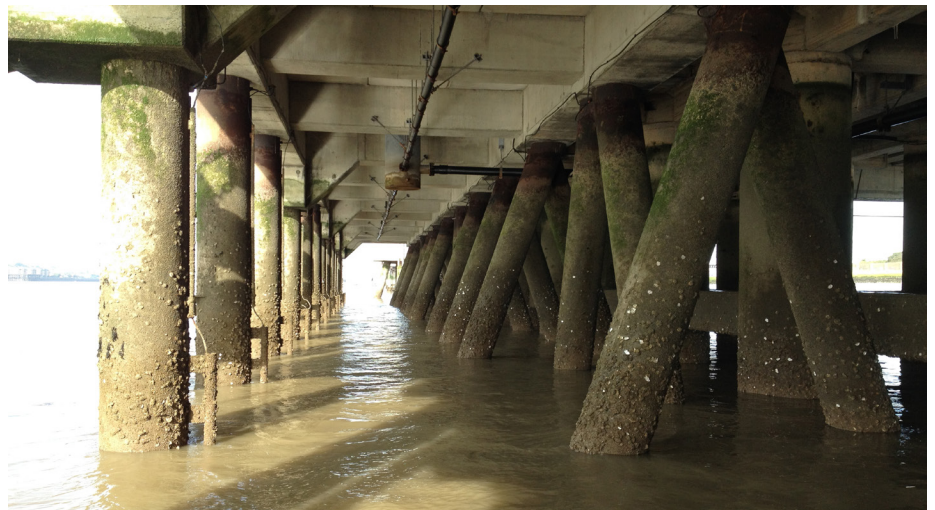
Jetty A extension structure

Condition surveys were carried out in 2015, which confirmed that, for the age of the structures, the jetties were in reasonable condition. The extension for Jetty A and the mooring dolphins were in good condition and therefore were expected to be able to effectively serve as the berth frontage for the proposed new RoRo berths.

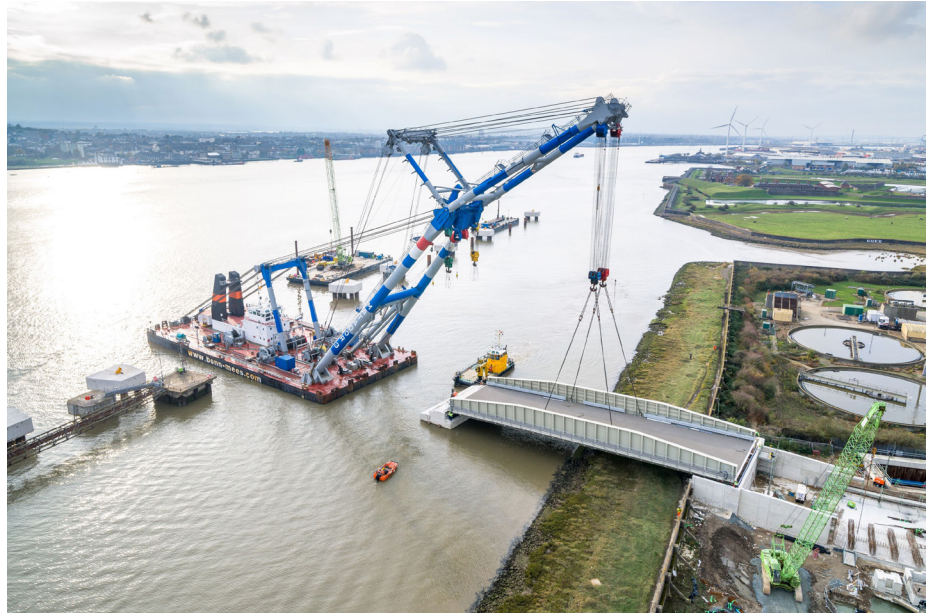
Approach bridge as constructed being lifted into position

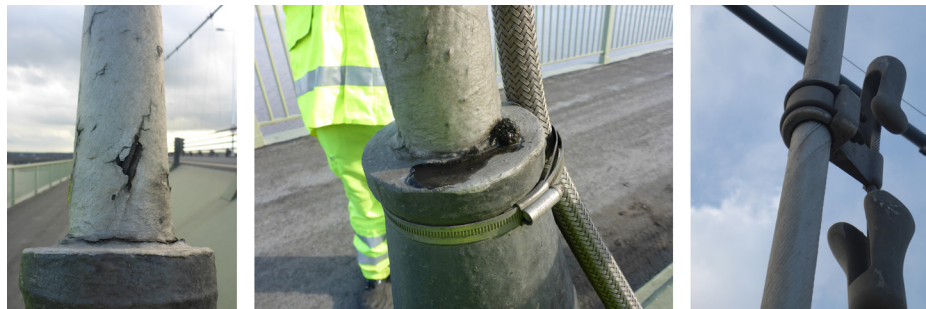
Typical hanger defects

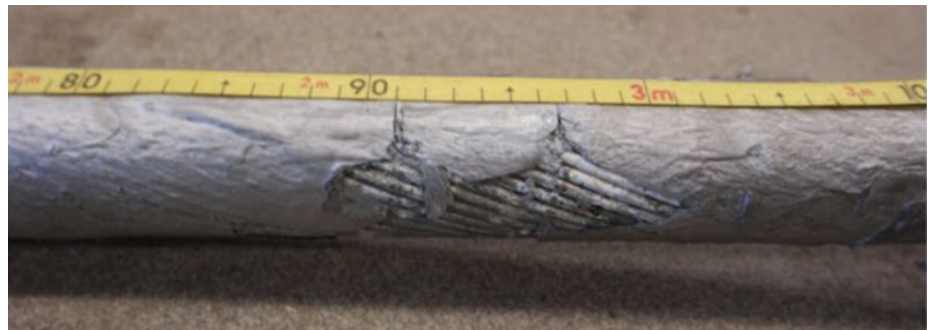
FIGURE 10

Hanger 9-10 was visually in a worse condition than hanger 17-18 with areas of exposed wires and corrosion, as shown in Figure 10. In addition, individual wires could be seen out of lay in several locations.

Hanger 9-10

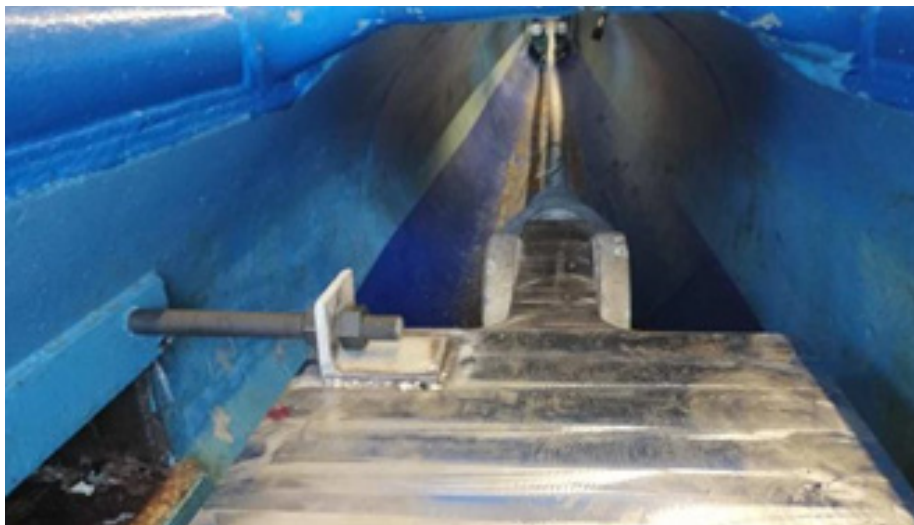
**FIGURE 11**

Hanger 17-18 was tested first in accordance with the stress range of 78MPa and set-up described in section 4.2. The rig is shown in Figure 11. A fabricated adaptor tool with a threaded bar was used to maintain the required misalignment of the upper and lower hanger sockets such that this force was not transmitted to the hydraulic system. The test rig was set to a nominal 58kN (2% of minimum breaking load) to allow final inspection and measurement prior to the test starting and acoustic monitoring was installed to detect wire breaks occurring during the test, which took 35 days to complete. One possible wire break was detected by the monitoring system after approximately 89,000 cycles, but no wire break was evident on visual inspection after the test until subsequent dismantling as described in section 6.3.

Fatigue test rig  
(hanger 17-18)

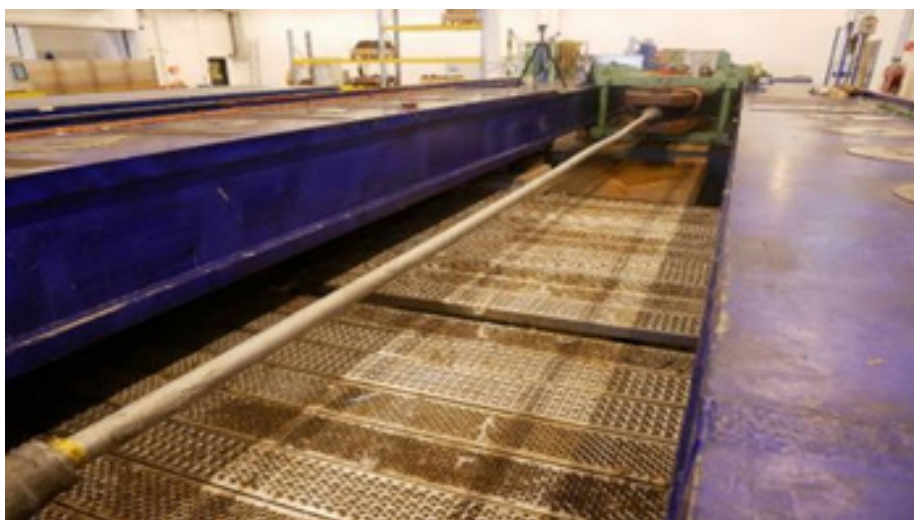
Tensile test rig  
(hanger 16-17)

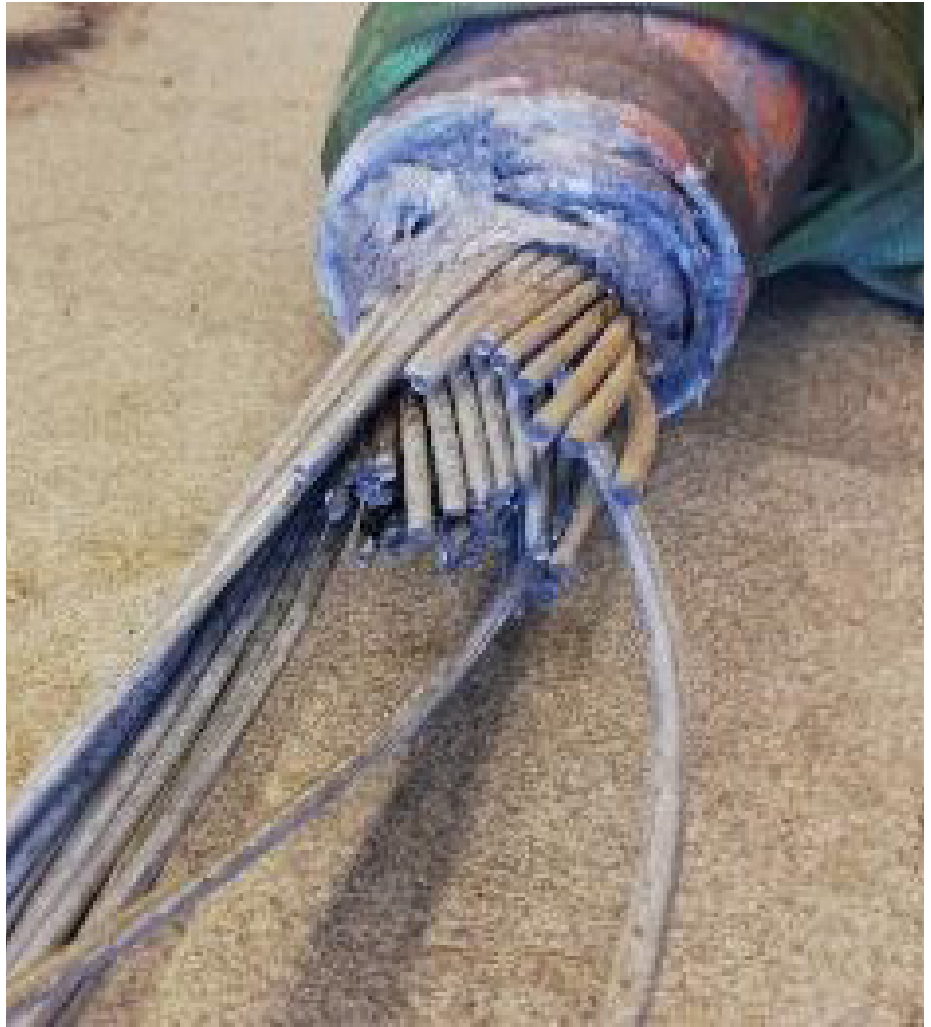
Hanger 16-17 was tested first and had not undergone prior fatigue testing. Failure occurred adjacent to the cable top anchorage (see Figure 13 and Table 6) at 3.4% average strain, which was greater than the minimum value specified of 2%. The measured breaking load also exceeded the 95% minimum breaking load as required.

Tensile test failure in  
hanger 16-17 (other  
hanger failures similar)

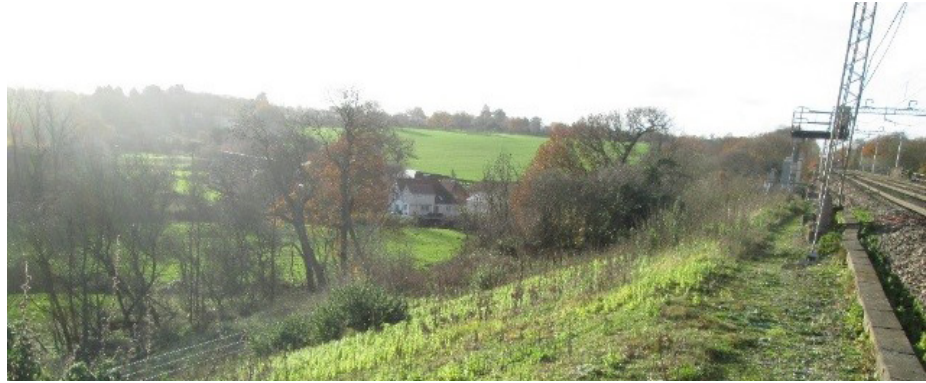
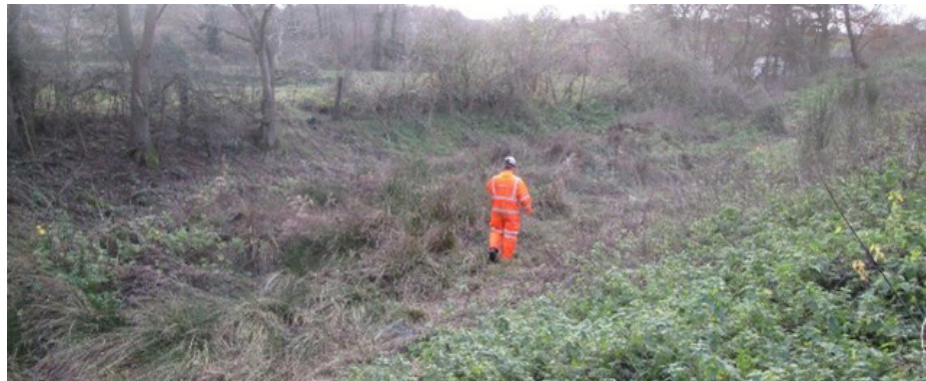
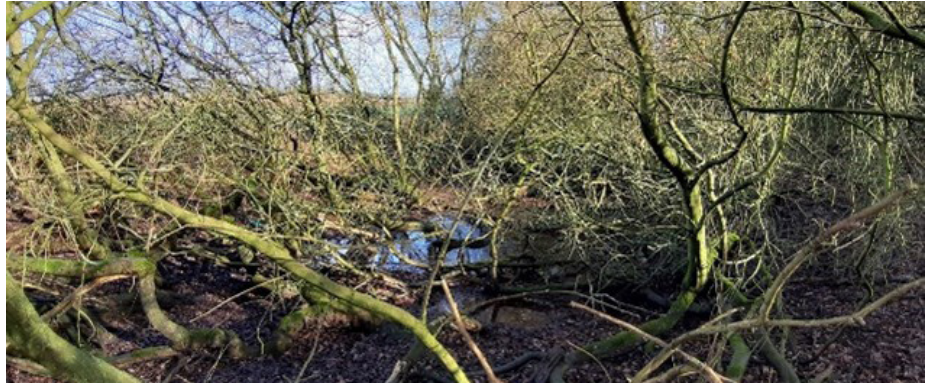
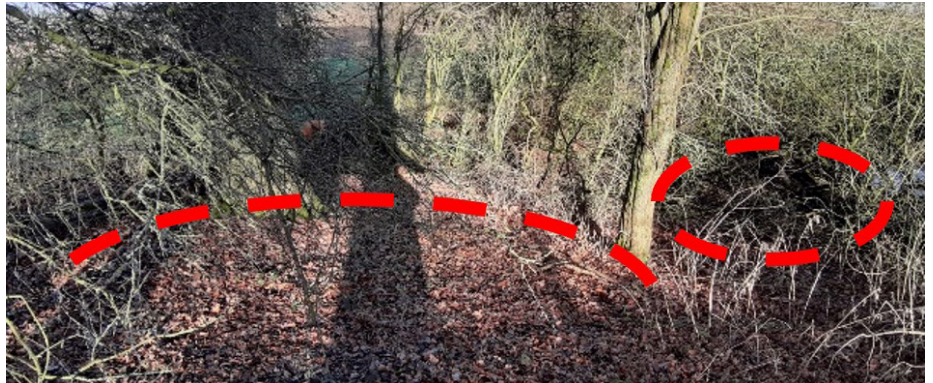
Site walkover observations  
of the earthwork slope

- A) 49m 73 to 75ch Up Good condition slope above existing sheet pile wall earthwork renewal

- B) 49m 74ch Up Hydrophilic vegetation and ponding at toe beneath sheet pile wall earthwork renewal

- C) 50m 01 to 05ch Up Toe berm – ash and clinker construction – possible historic stabilisation

D) 49m 77 to 78ch Down Ponding at slope toe – opposite worst defect on Up Side

E) 49m 76ch Down Historic toe bulge blocking toe ditch causing ponding at slope toe

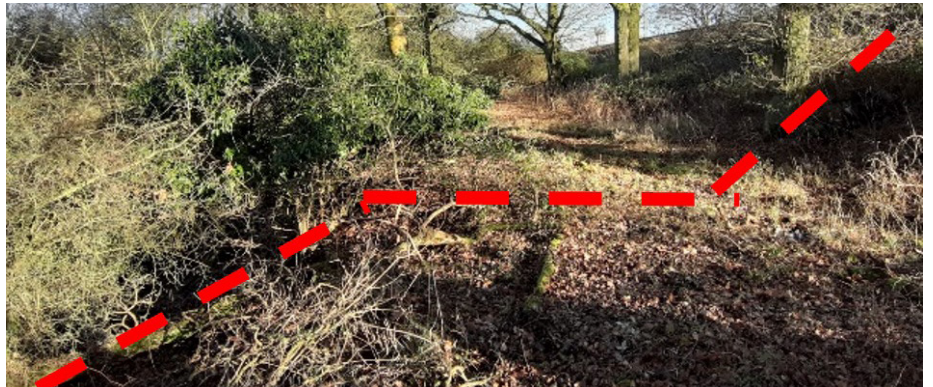
F) 50m 05 to 12ch Down Toe berm on slope – possible historic stabilisation?

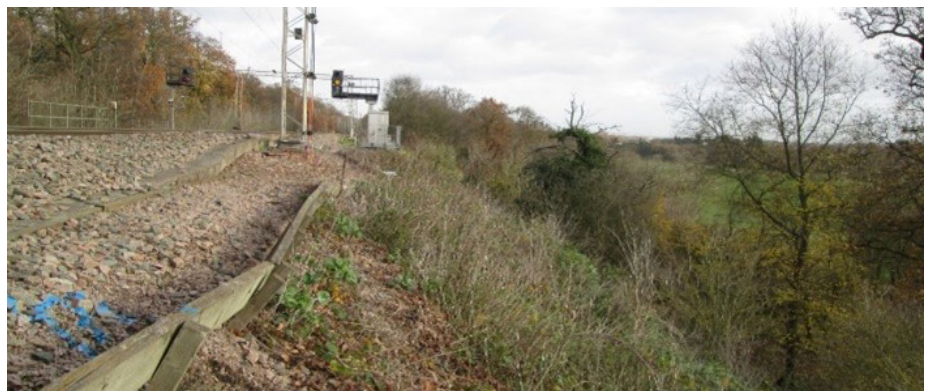
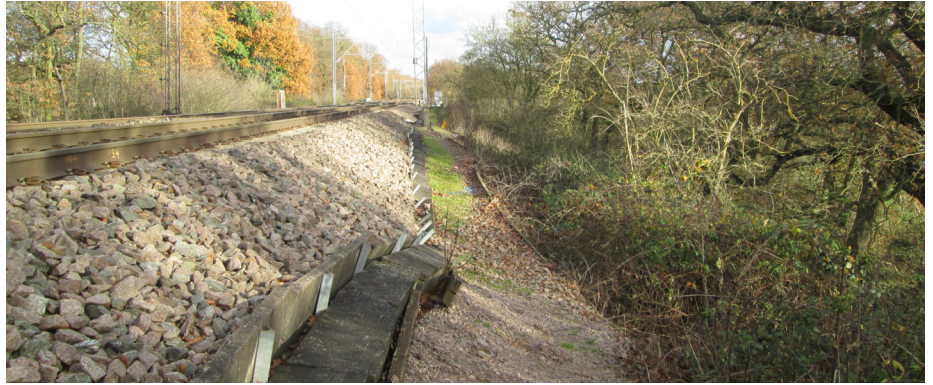
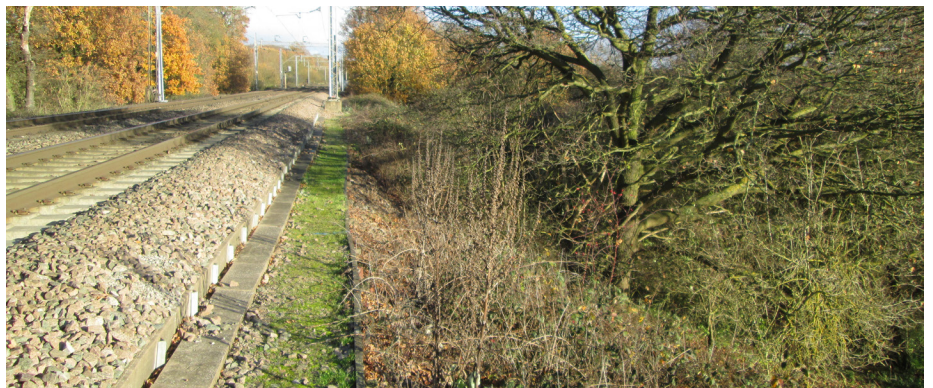
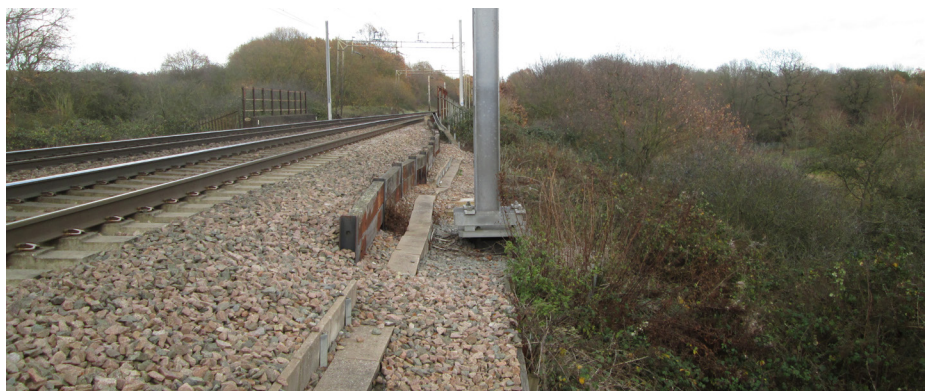
Site walkover observations  
at track level

A) 49m 71ch Up Exposed sleeper ends, ballast spalling down slope and failing cess

B) 49m 78ch Up Large dip in cess walkway and associated track dip

C) 50m 05ch Up Cess area in better condition compared to the rest of the site

D) 50m 15ch Up Sleeper ends exposed, poor cess condition. A small king post retaining wall has been constructed to retain ballast at this location.

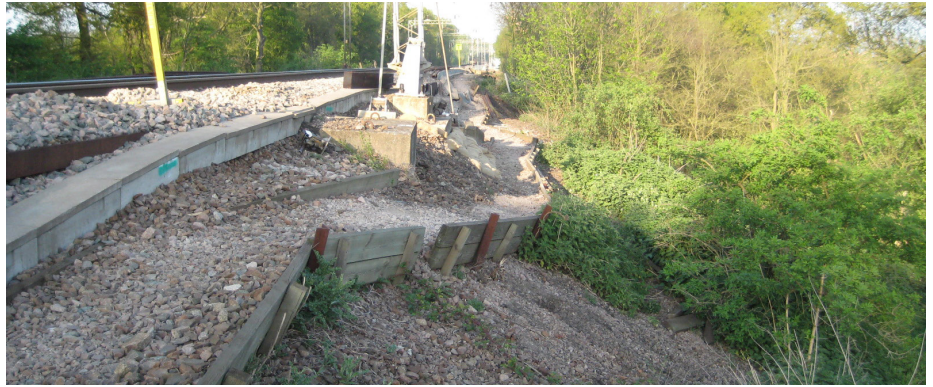
FIGURE 6

Recent earthwork  
remediation

- A) 50m 73 to 75ch Up Distorted cess walkway and temporary speed restriction (TSR) speed board, in early 2011 prior to remediation

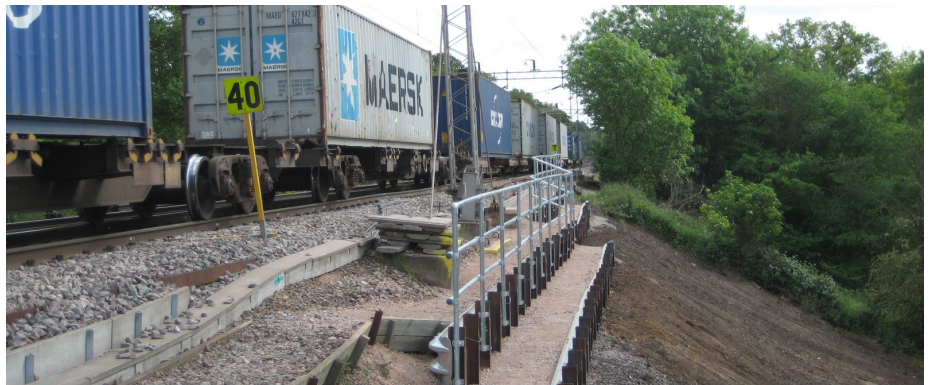
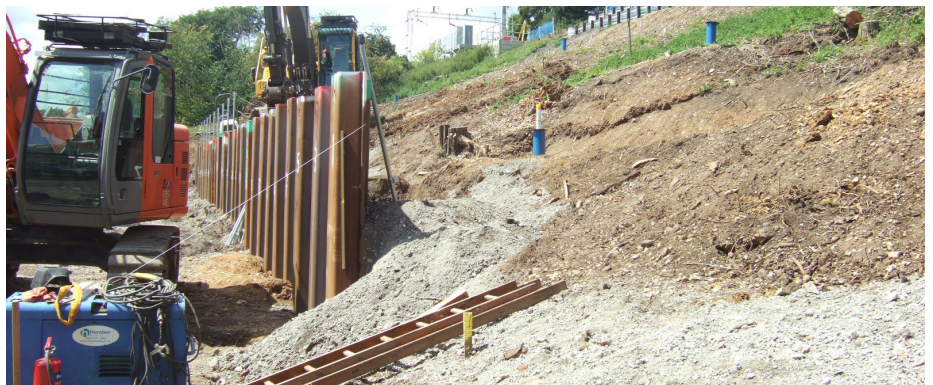
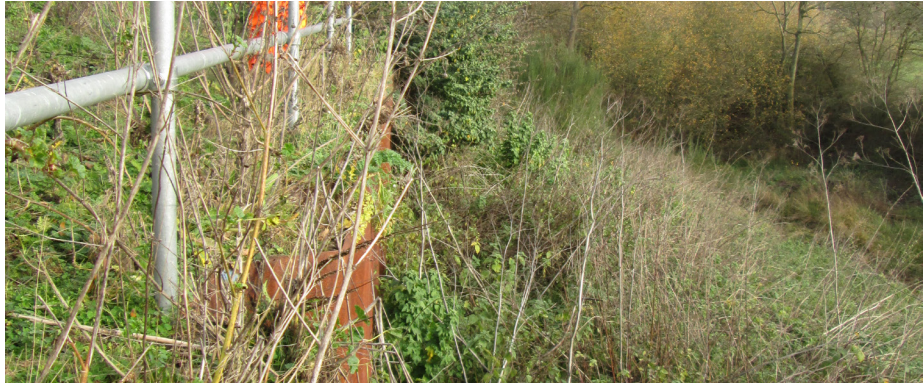
- B) 50m 73 to 75ch Up Two rows of cess retention constructed during May 2011, the slope continued to deteriorate shortly after construction due to deep seated failure (URS, 2011)

- C) 50m 73 to 75ch Up Sheet pile wall constructed in summer 2011 to replace the failing cess retention and address deep seated failure mechanism (URS, 2011)

D) 50m 73 to 75ch Up Recent photo along sheet pile wall showing good horizontal alignment.

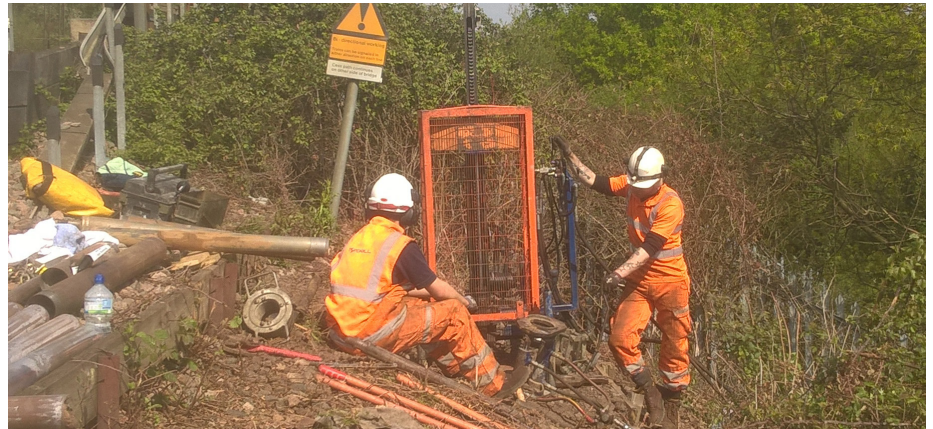
## FIGURE 7

Ground investigation  
utilising a LLAMAR drilling  
rig and a rotary drilling rig

A) LLAMAR Rig set up at embankment crest at Country end of site for window sampling.

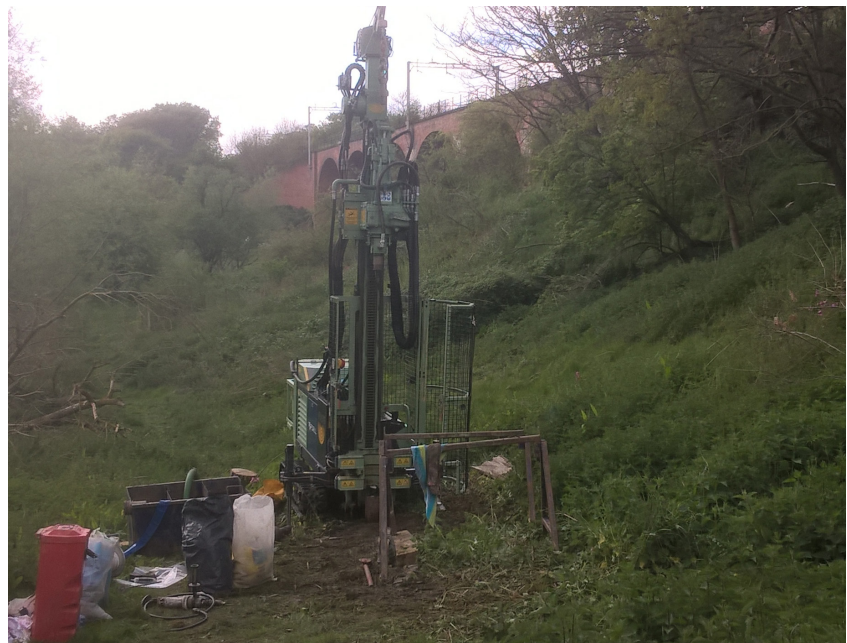
B) Rotary rig set up at embankment toe at London end of site for continuous sampling

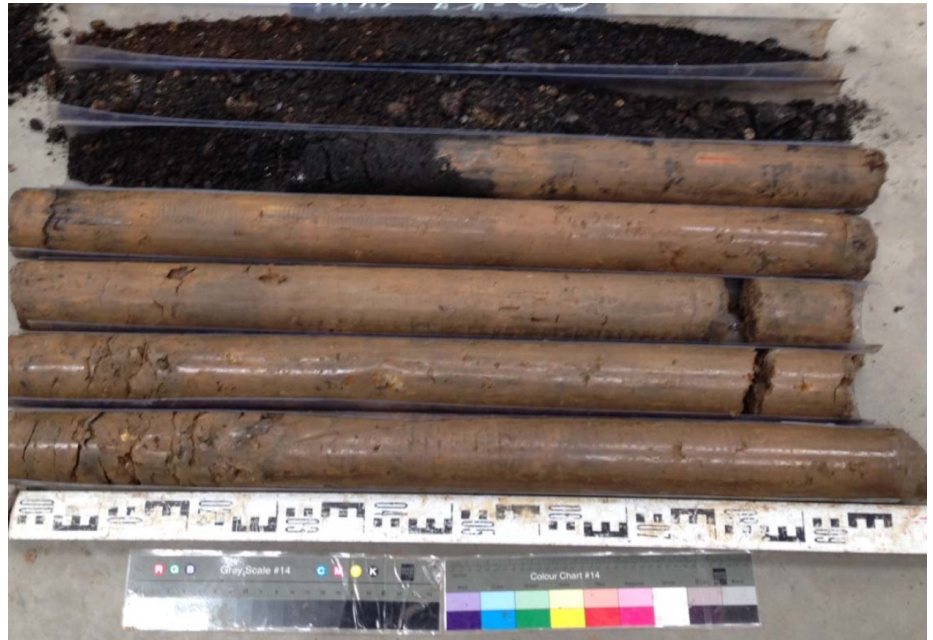
FIGURE 9

Embankment fill  
material encountered  
during 2015 GI works

A) Ash and clinker overlying cohesive embankment fill in upper slope

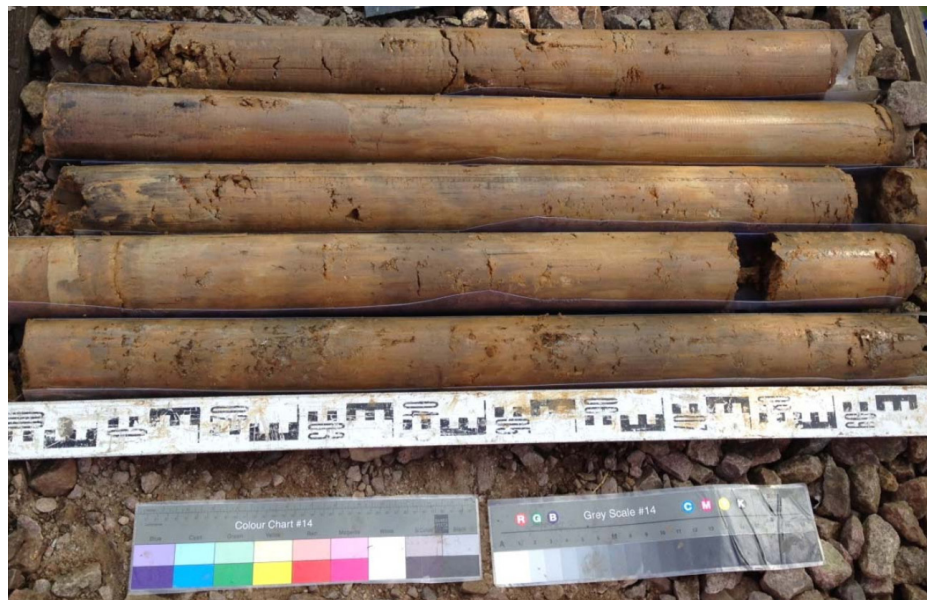
B) Absence of ash and clinker in lower slope.

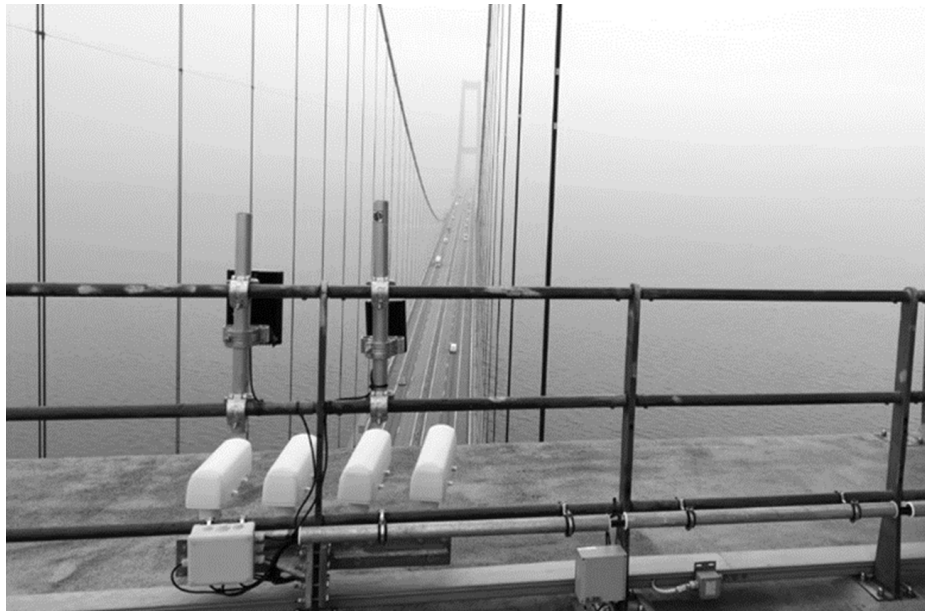
FIGURE 5

DIC camera system

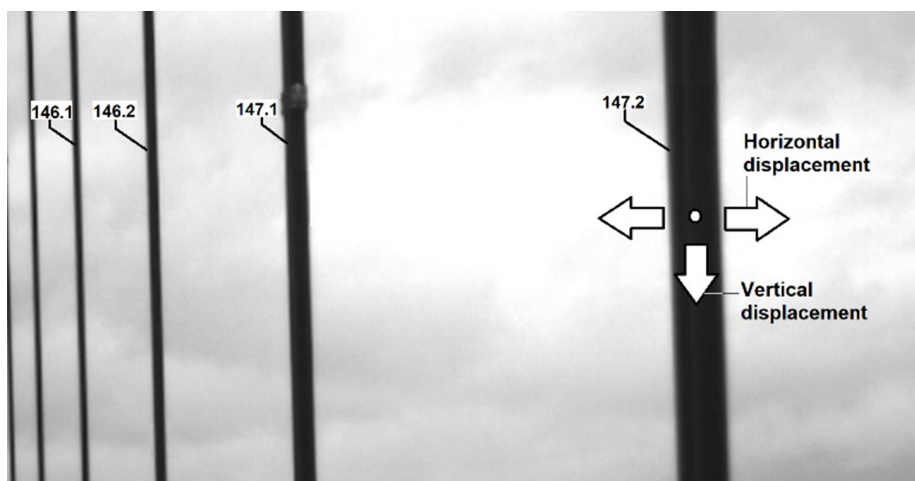
**FIGURE 6**

The normalized greyscale correlation tracking algorithms were used for the image analysis. Calibration was achieved by measuring a distance within the image. No editing of the raw data has been undertaken. The permanent system allows for offline analysis. The DIC camera system has been successfully collecting video data for more than one year. FoV obtained from the system is shown on Figure 6.

Longest hangers on the  
Great Belt Bridge

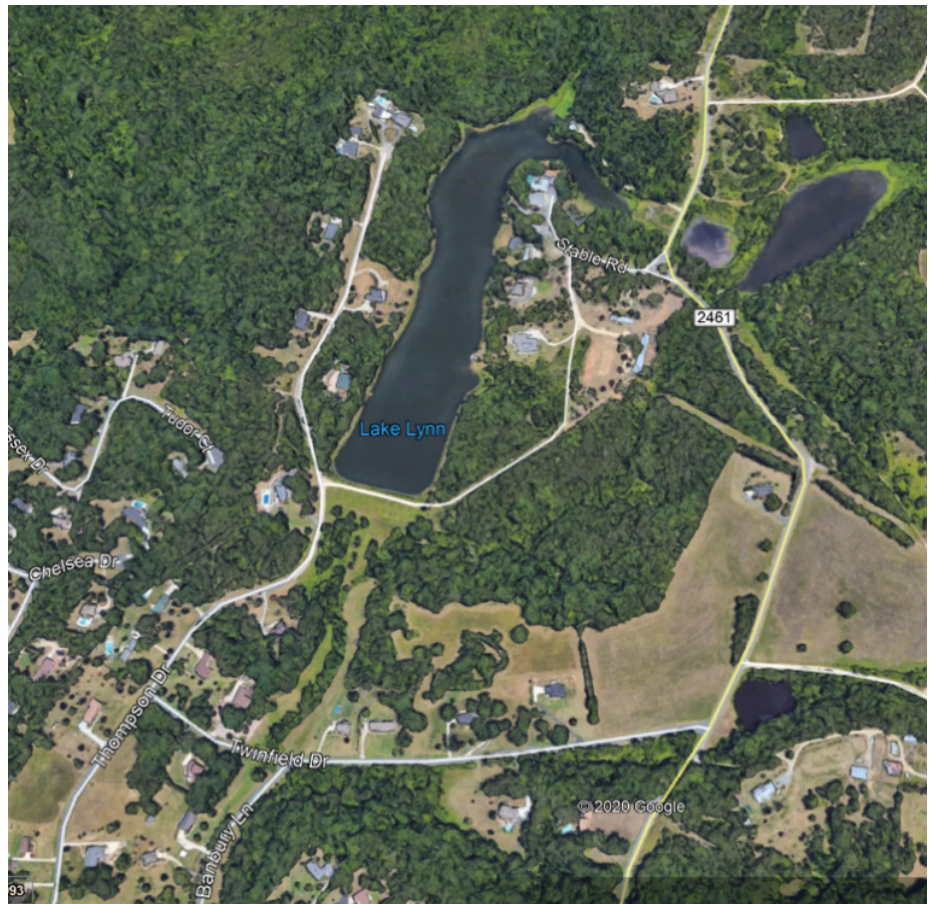
FIGURE 1

Lake Lynn Dam, Reservoir  
and downstream area, NC

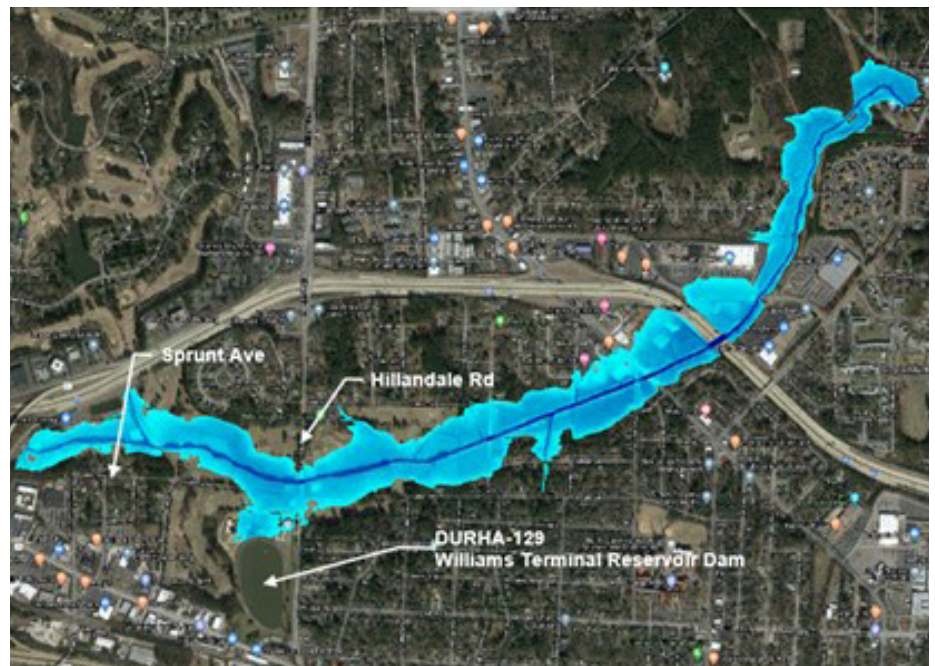
**FIGURE 7**

Location and overtopping  
breach inundation
